**A report for the Trustees of the Science Museum Group into the restoration of A3 Class Pacific  
*Flying Scotsman* and associated engineering project management.**

**Researched and written by Robert Meanley**

26 October 2012

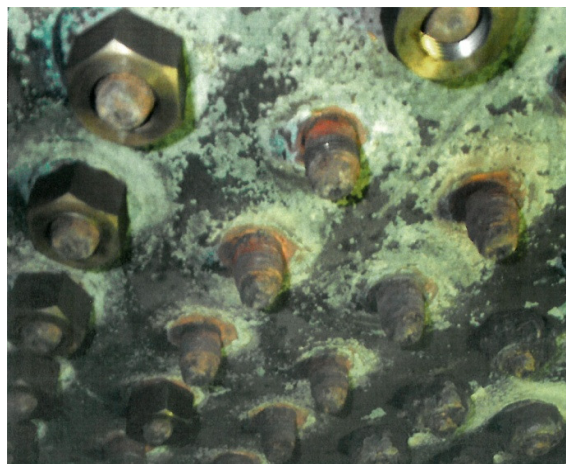
*Maintenance action was being carried out to the rear six to eight rows of roof stays. New stay nuts were being fitted. The previously fitted nuts exhibited signs of overheating and the stay ends were notably wasted or burned.*

The AEAT report included a number of photographs, including *Figure 1: Roof stay nuts*, which illustrates the point made in the interview and does not seem to back-up the rather rosier picture painted by the written report.

*Figure 1: Roof stay nuts (Photo: AEAT)*

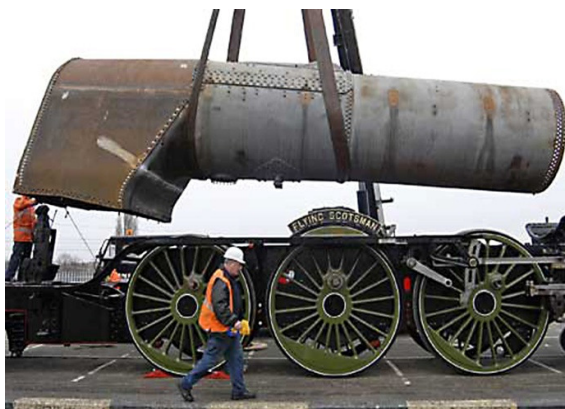
*Figure 2: Trial fit of boiler at Riley and Son (Photo: NRM)*

Later in 2008, boiler components were returned to Riley and Son, only for them to discover that there were a number of cases of defective workmanship including misaligned rivet holes and defective welding. Much of the completed work had to be returned to Pridhams for rectification and re-welding. It was 2009 before any meaningful work resumed at Riley and Son and the repairs on the boiler were finally brought to completion with the successful hydraulic test on 17th February 2011 followed by steam testing on the 21st February 2011 – almost 4 years after the contractual completion date.

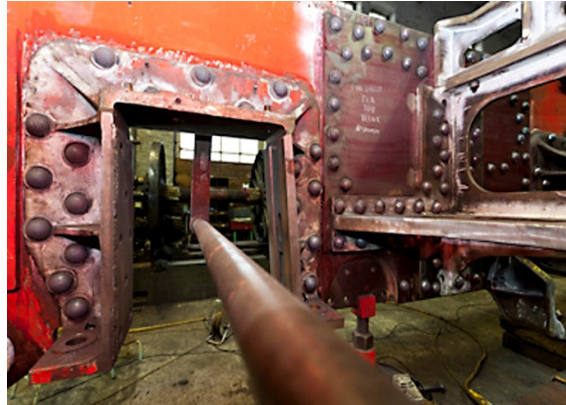
- Jun-11 Within days of the locomotive's return to Bury, cracks are discovered in the frame hornblocks. Arrangements are made to strip the running gear again and lift the frames from the wheels to conduct ultra-sonic frame testing.

Figure 3: Newly-installed horn block (Photo: NRM)

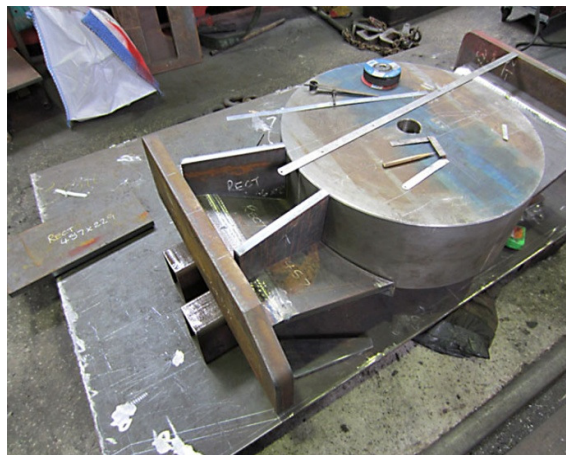
- Sep-11 Ultrasonic testing of No. 4472's frame stretchers confirms the 'worst case scenario'. All of the locomotive's frame stretchers (the horizontal steel braces which tie the two side plates together) are cracked; the main stretcher is deemed 'beyond repair'. The centre-cylinder motion bracket also has cracks, and is condemned. The A3 is dismantled again, and the boiler lifted out of the frames once more by Riley & Son at Bury.

Figure 4: Components of bogie stretcher in manufacture (Photo: NRM)
